Best Practice

Managed Solutions

List of Contents

Report on Asbestos Containing Materials in the Workplace

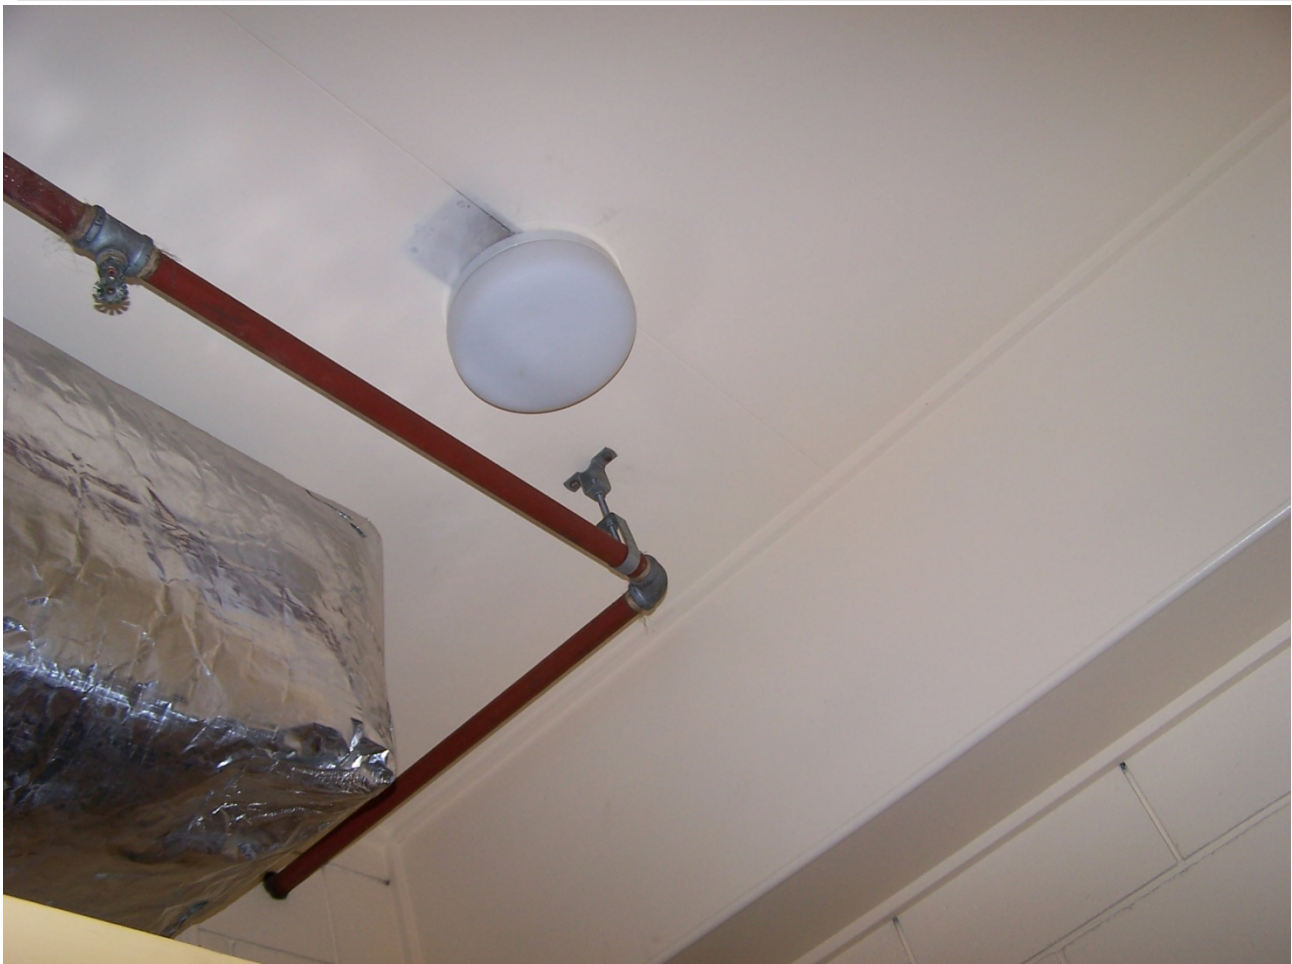
Component: Ceiling lining Type: Presumed
Form: A/C Sheet State: Bound
Condition: Good Risk Rating: Low
Building Owner: Client Name:

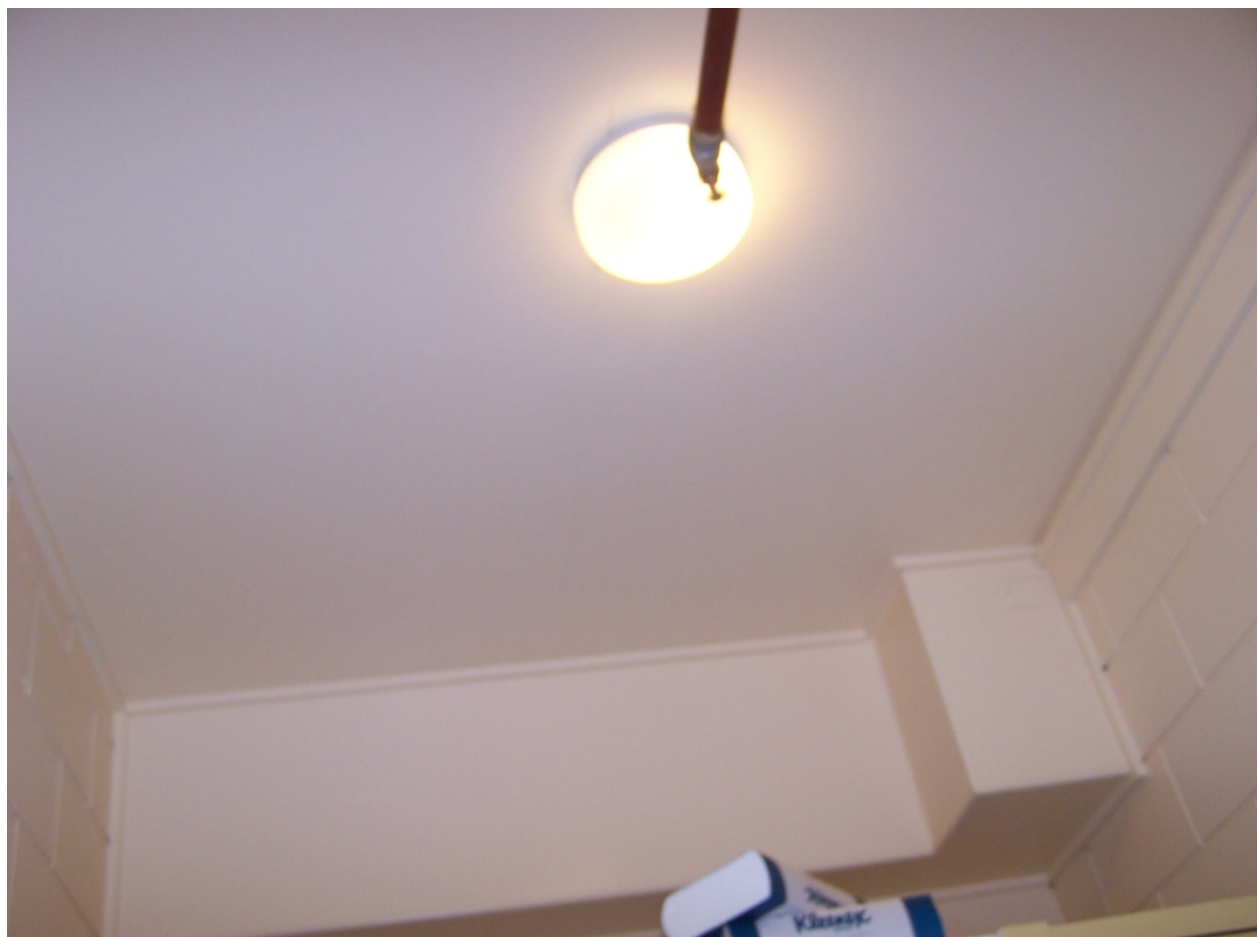
Component: Ceiling lining Type: Presumed
Form: A/C Sheet State: Bound
Condition: Fair Risk Rating: Low
Building Owner: Client Name:

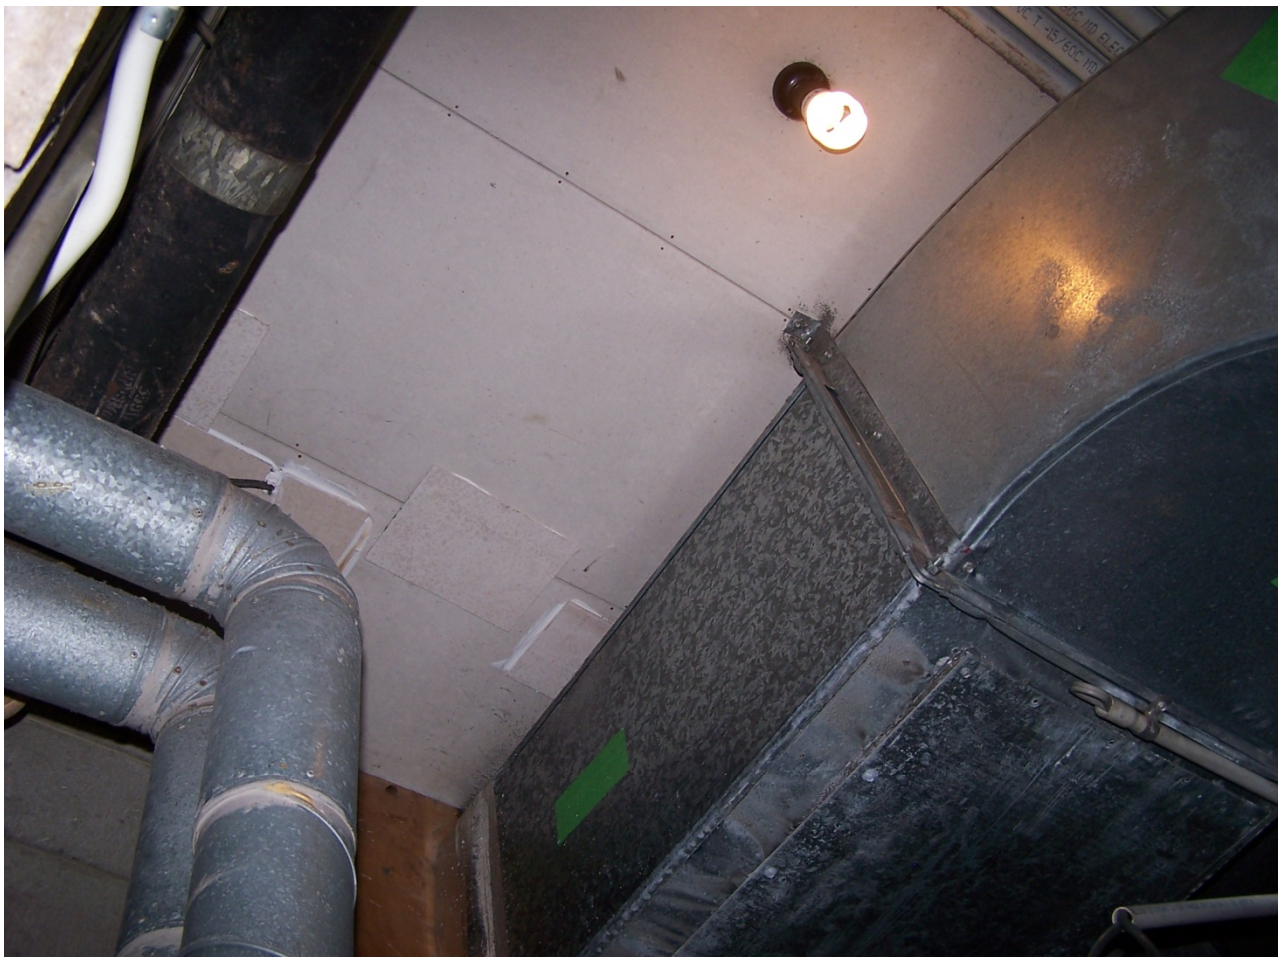
Component: Ceiling lining Type: Presumed
Form: A/C Sheet State: Bound
Condition: Poor Risk Rating: Medium
Building Owner: Client Name:

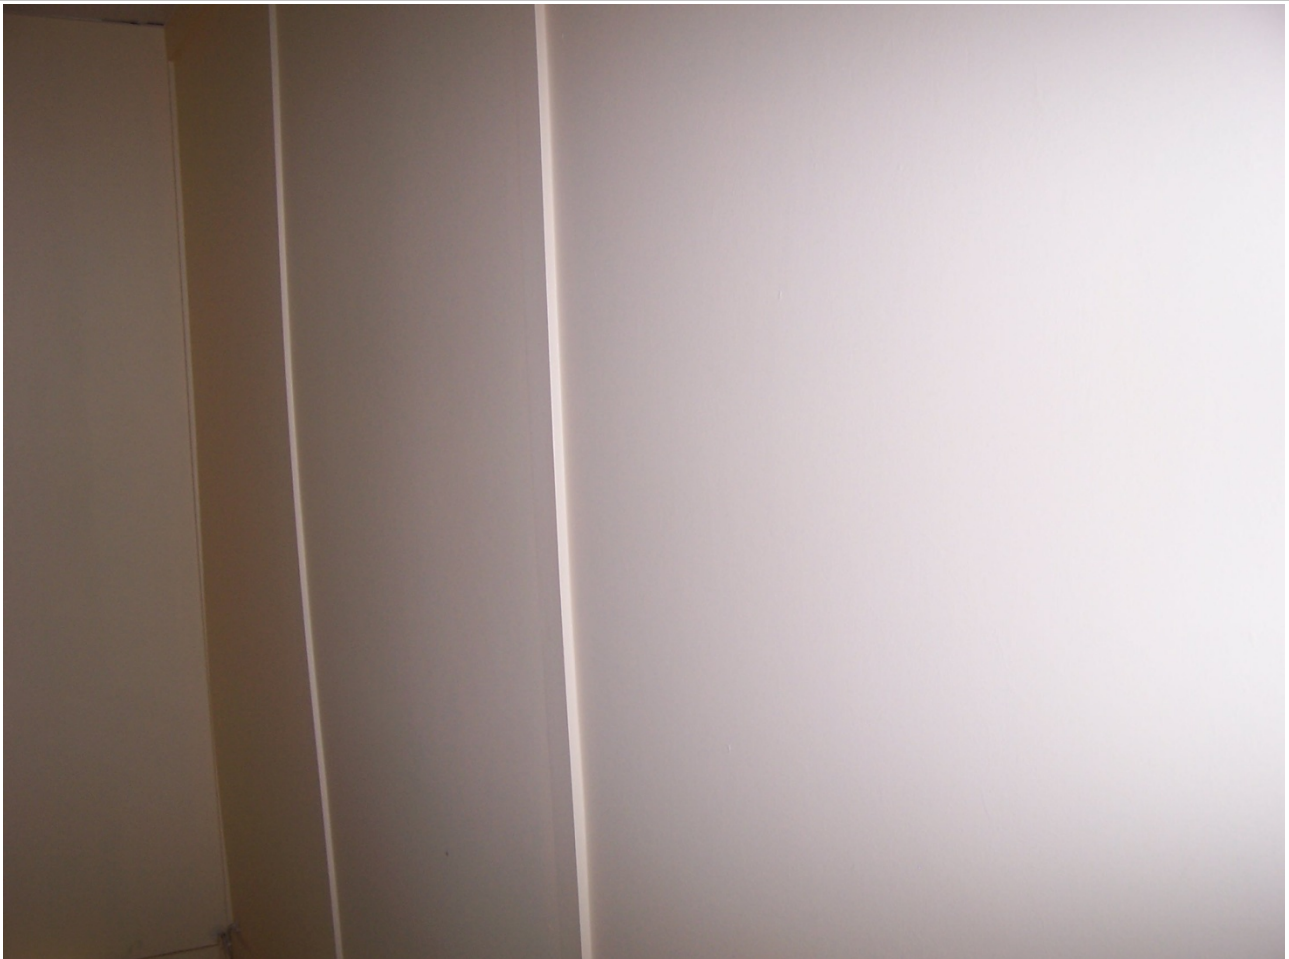
Component: Ceiling lining Type: Presumed
Form: A/C Sheet State: Bound
Condition: Good Risk Rating: Low
Building Owner: [REDACTED] Client Name: [REDACTED]

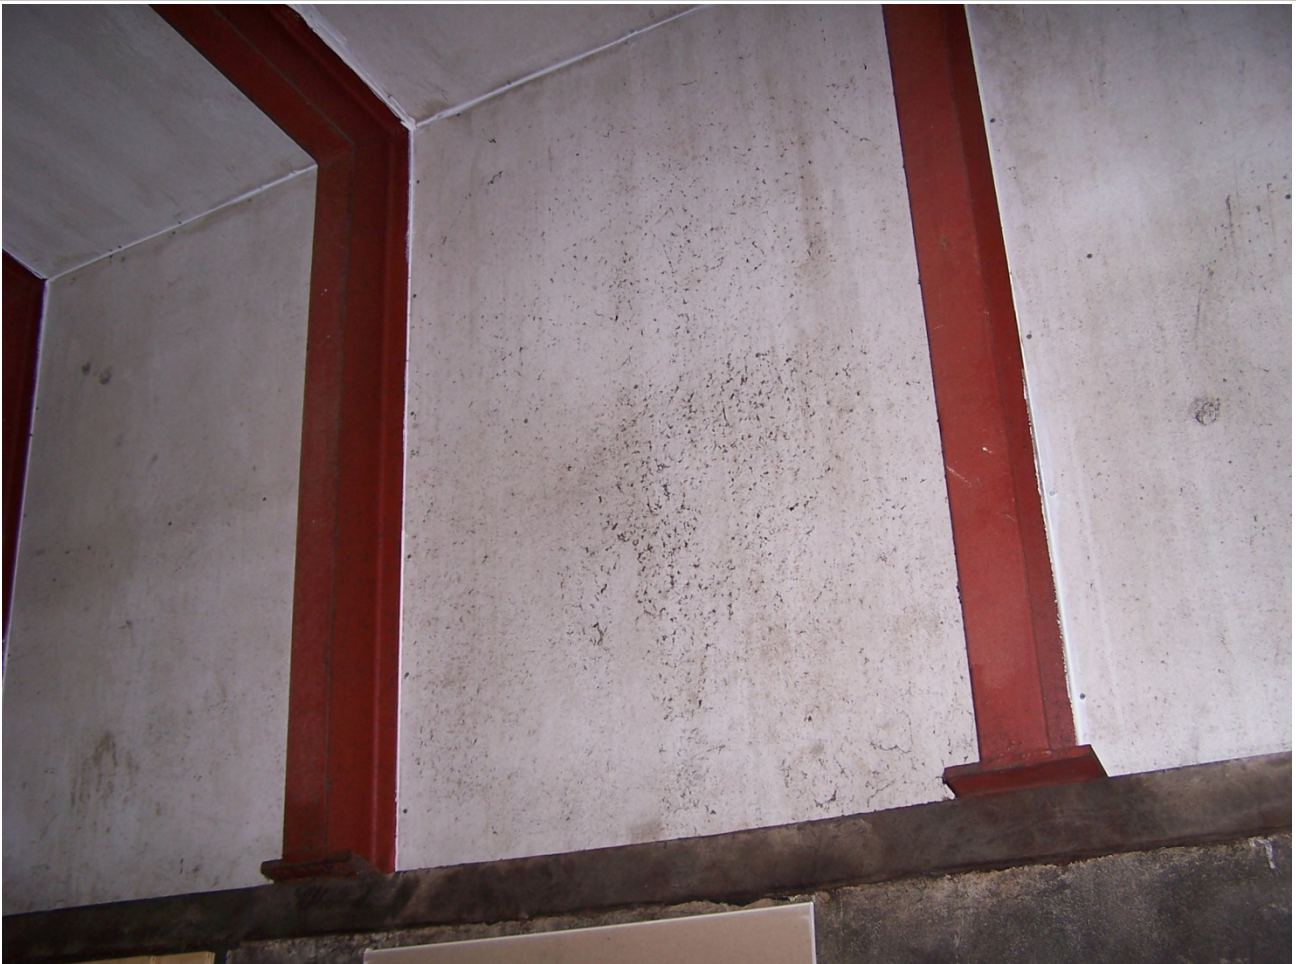
Component: Ceiling lining Type: Presumed
Form: A/C Sheet State: Bound
Condition: Fair Risk Rating: Medium
Building Owner: Client Name:

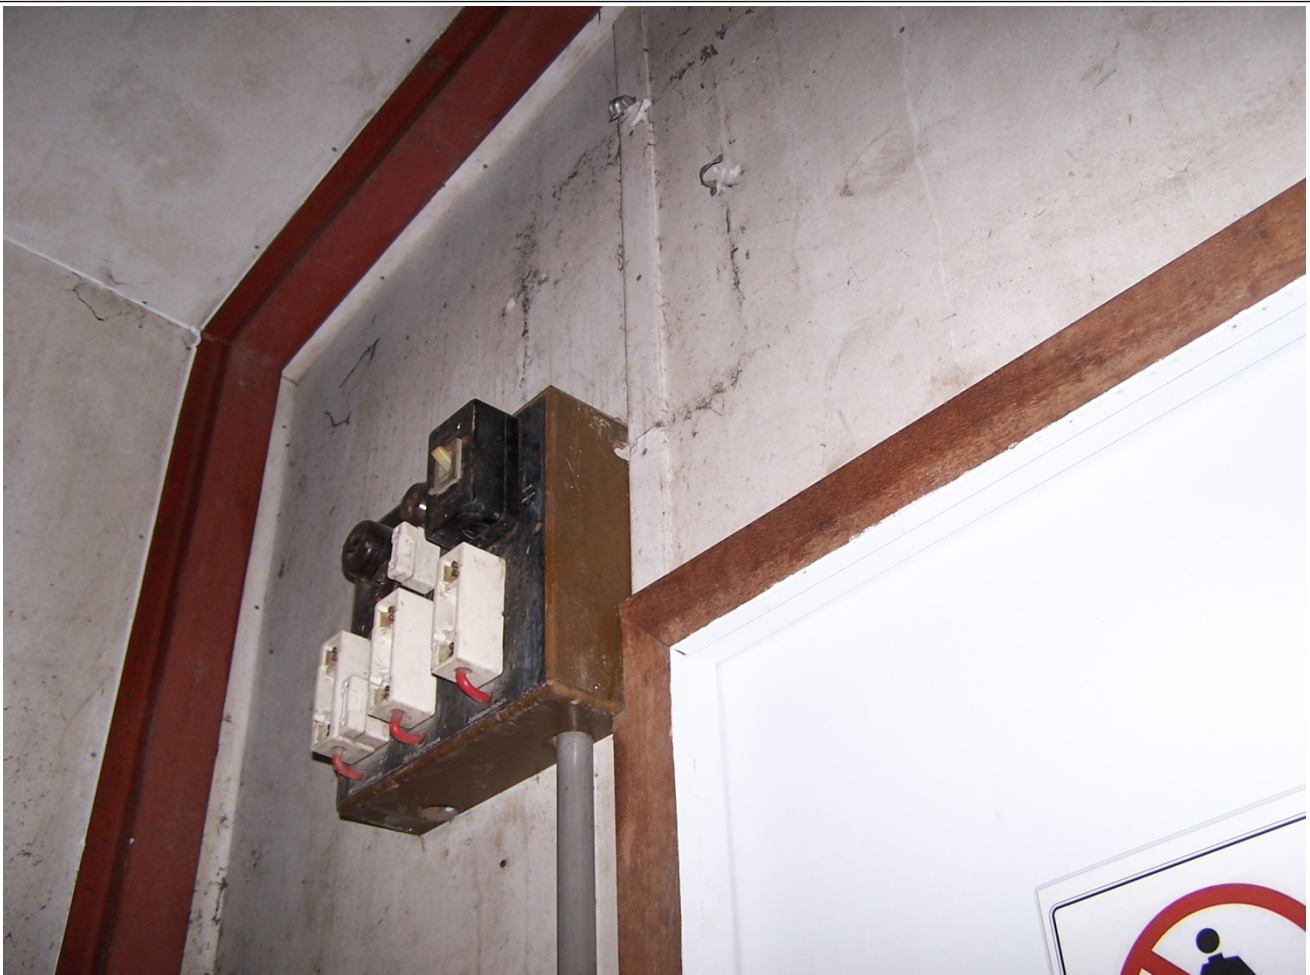
Component: Cladding Type: Presumed
Form: A/C Sheet State: Bound
Condition: Good Risk Rating: Low
Building Owner: Client Name:
